**RESEARCH ON ADVANCED NONDESTRUCTIVE  
EVALUATION (NDE) METHODS FOR AEROSPACE STRUCTURES**

**FINAL REPORT FOR 9 SEP 94 THROUGH 30 SEP 98**

**MATERIALS AND MANUFACTURING DIRECTORATE  
Air Force Research Laboratory  
Air Force Materiel Command  
Wright-Patterson AFB, OH 45433-7817**

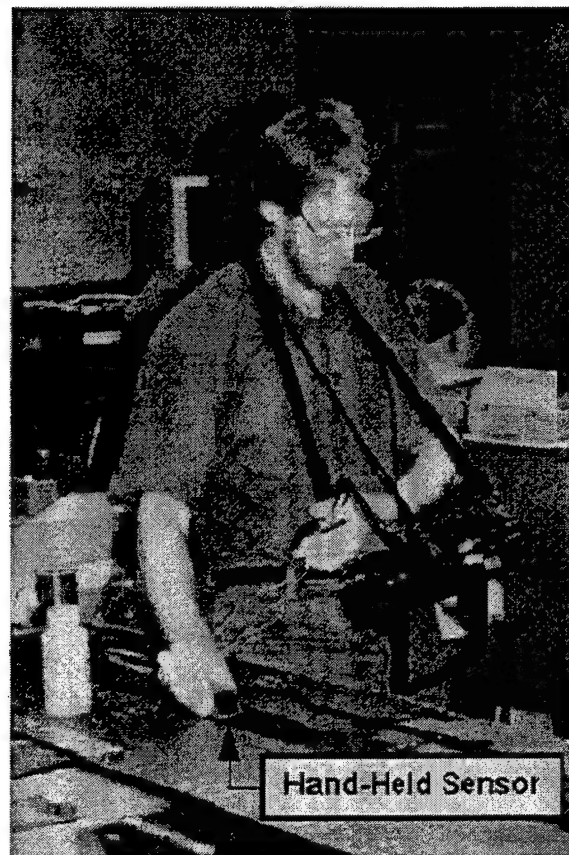
**FIGURE 4.1-8**  
**Laboratory Application of Transducer (hand-held sensor).**

In either mode, a portion of the incident acoustic pulse is specularly reflected from the near side of the hole; this signal is used as a time reference to judge the arrival time of the two possible situations for the creep wave. For an uncracked hole, the creep wave travels circumferentially around the hole and leaks back to the receiver (pitch-catch mode) at a time determined by the diameter of the hole. If the creeping wave encounters a crack emanating radially from the weep hole, a portion is reflected back toward the transmitting transducer and is detected in the pulse-echo mode. These conditions are illustrated in Figures 4.1-1 through 4.1-6, obtained from actual condemned C-141 wing panels. An optical photograph of a typical weep hole is shown in Figure 4.1-7, and the transducer is shown in use in Figure 4.1-8.
